COMMISSION FOR HISTORICAL & ARCHITECTURAL PRESERVATION

STAFF REPORT

REQUEST: Retain Unapproved Exterior Work

ADDRESS: 1000 W. Lombard Street (Union Square Historic District)

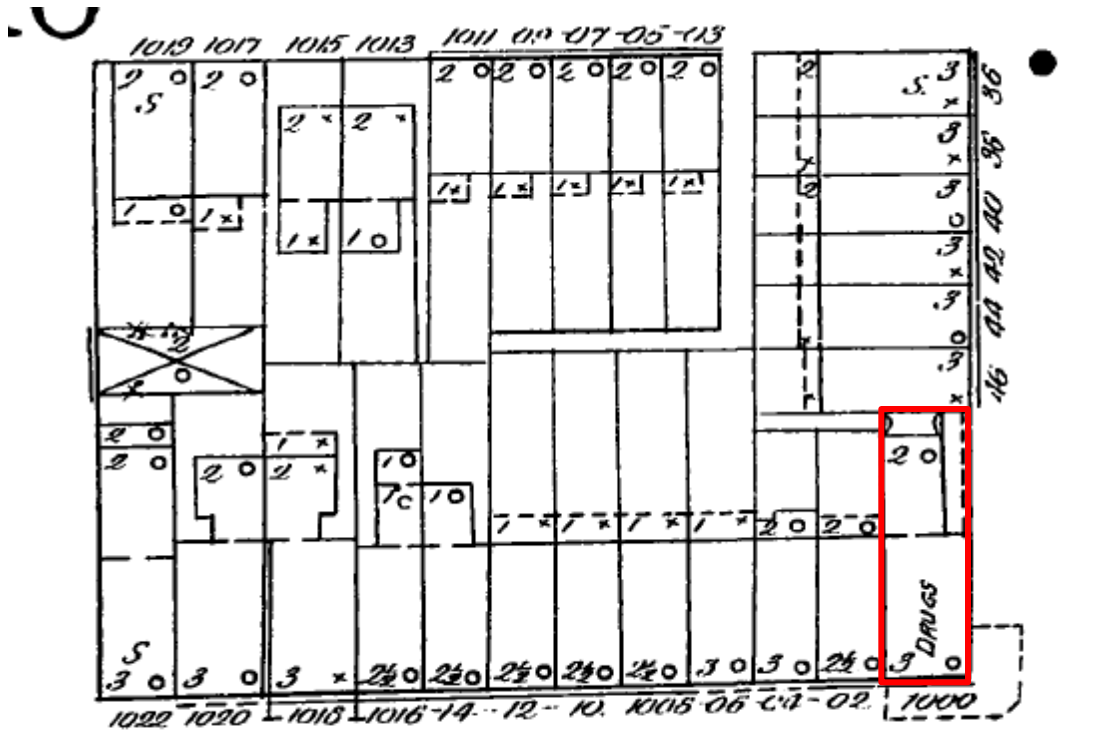
Image 3: Sanborn Map, 1890, 1000-1022 W. Lombard Street

Site Conditions/Architectural Description: The site is in the southeast corner of the local historic district on the north side of Lombard Street at S. Schroeder Street (*Image 1*). The building is a three-story three-bay corner rowhouse with a liquor store/bar on the first floor (*Image 2*). The 1890 Sanborn map of the section of this block between Schroeder and Mount Clare, an alley street, shows 1000 W. Lombard as a corner drug store (*Image 3*). The upper two floors of the Lombard Street façade contain one-over-one windows. The façade and lintels are covered in Formstone. Most first floor historic storefront details have been covered or removed—prior to the latest changes—with the exception of the band or fascia between the first and second floor that wraps around to a portion of the S. Schroeder Street side (*Images 4 & 5*).

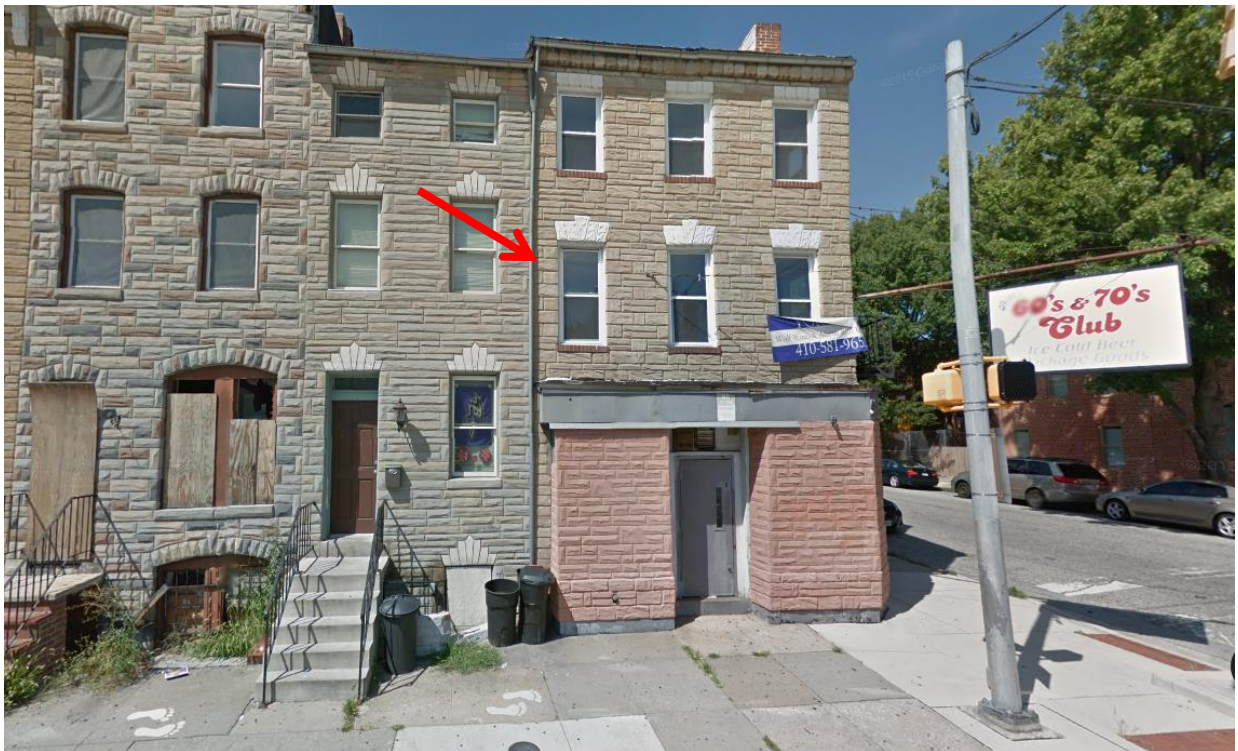
Image 4: 1000 W. Lombard, Google Street View, August 2015

The building retains little character-defining fabric at the ground floor. Formstone covered two windowless bays on either side of a metal door. Any indication of a former storefront is seen in the band between the first and second floor, and a bit of Craftsman style detail in a bracket on the Schroeder Street side. For these reasons, staff approved alterations to what was already a substantially altered storefront, including removing the Formstone-covered bays.

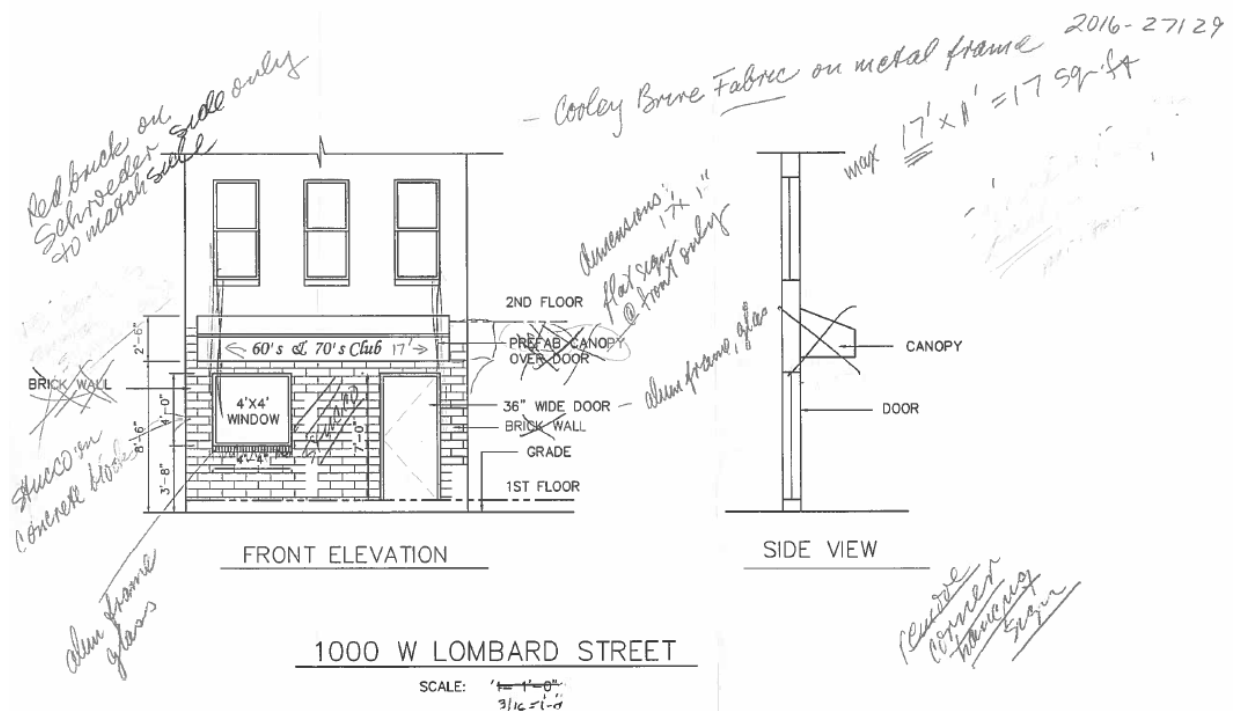
Image 6: Approved plan, with mark-ups by CHAP staff, October 26, 2016.

by removing the Formstone-covered bays, installing a window, moving the front door, installing signage and installing a canopy (*Image 6*).

- October 25, 2016—CHAP staff, Walter Gallas, visited the site.
- October 27, 2016 –After the site visit, and after discussing the proposed plan with the applicant and CHAP director Eric Holcomb, and making notes on the plans while meeting with Mr. Mirze, Gallas wrote an Authorization to Proceed. Among the items approved in the ATP: a flat unlit sign of maximum dimension of 17’-0” by 1’-0” attached in the space between the 1st and 2nd floors on the Lombard Street side and removal of the corner hanging sign and supports. *No awning of any kind was approved, neither was an ADA ramp, a roll-down door, a window on the Schroeder Street side nor an awning over the Schroeder Street doorway.*

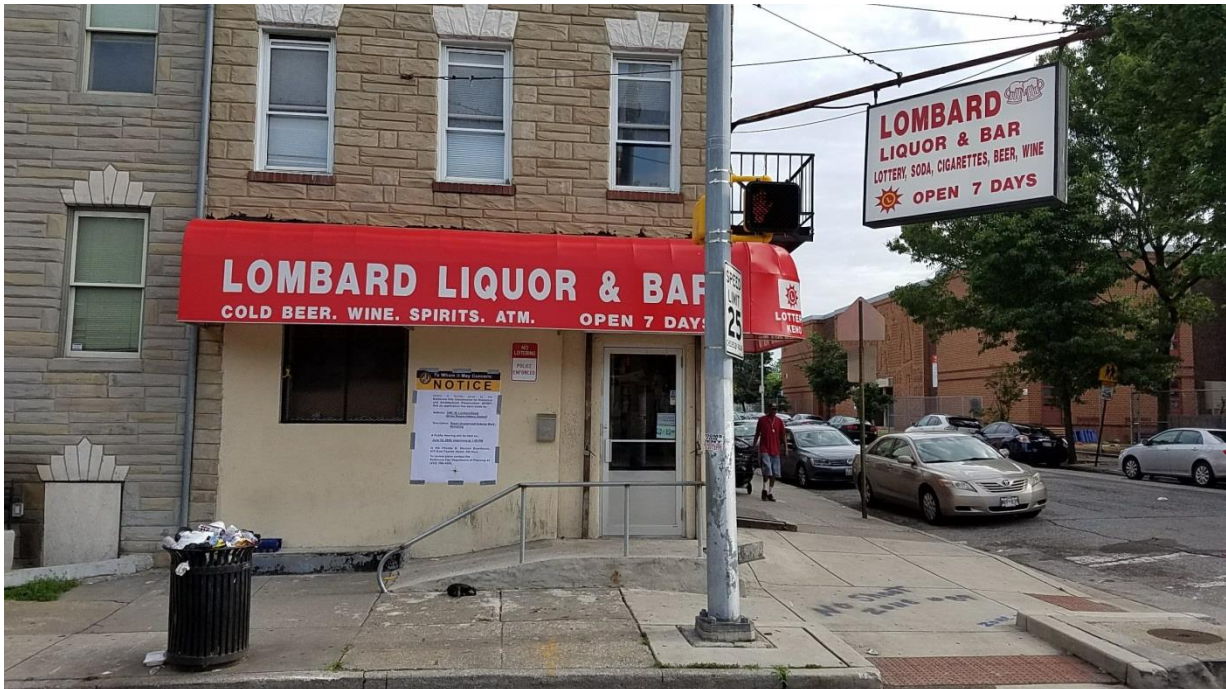
The applicant proposes to retain the unapproved exterior work (*Images 7 & 8*). This includes:

- A vinyl barrel awning with signage on the Lombard and Schroeder Street sides
- A hanging corner sign with additional signage
- A metal roll-down door at the front entry
- A concrete ramp on a portion of the front sidewalk
- A window on the Schroeder Street side
- An awning over a door on the Schroeder Street side
- Blinking lights in windows

There were no historic materials or detailing in the entryway, and the most recent door was a metal door with small pane of glass. Therefore, staff permitted relocation of the opening with an aluminum frame glass door, provided that the right edge of the door aligned with the right edge of the second floor window above. These conditions were stated in the Authorization to Proceed. A metal roll-down door is not appropriate to a historic building of this type on a principal façade. It is an industrial feature and was not approved.

As with the entryway, staff determined that there was no historic fabric remaining at the windowless first floor on the primary facade, and therefore approved the installation of a single-pane aluminum frame window at the left, provided that the left edge of the window align with the left edge of the second floor window above. These conditions were stated in the Authorization to Proceed. While the doorway seems to come close to aligning with the right edge of the second floor window, the window on the front is not installed to align with the left hand edge of the second floor window. Staff did not approve a rectangular single-pane glass window which was installed at the Schroeder Street side, just around the corner from the entry door.

The approved signage was to consist of a flat sign on the front band (fascia) above the first floor, a remnant of the storefront. The sign was to be a fabric stretched on a metal frame with a maximum size of 17 feet by 1 foot, and not lit. In addition, the existing corner hanging sign from a previous business was to be removed along with the sign supports. An awning was not approved. Contrary to the Authorization to Proceed, a barrel awning wrapping the building at the Lombard and Schroeder corner and containing signage was installed. Also, contrary to the Authorization to Proceed, the corner hanging sign was not removed. Instead, this sign was retained and altered to advertise the current business. Staff did not approve an awning which was installed over a door on the Schroeder Street side.

The October 2016 CHAP application and Authorization to Proceed did not include an ADA ramp at the front entry. A ramp was under construction in December 2016. A ramp plan was submitted and approved through the city ePlans system in May 2017. While CHAP was not included in the sign-off, the plan would have met ADA requirements. However, an inspection by Housing has determined that the ramp was not constructed as approved, and Housing is taking action to resolve the matter.

Image 7: 1000 W. Lombard, June 2, 2018 – Left edge of ground floor window was to align with left edge of 2nd floor window above; right edge of new front door was to align with right edge of 2nd floor window directly above.

- **CHAP staff recommends a finding of disapproval of the request to retain the exterior work performed without CHAP approval, and which does not meet CHAP design guidelines.**
- **The owner should work with staff to remove the unapproved alterations as soon as possible and make corrections that conform to the October 27, 2016, Authorization to Proceed.**
